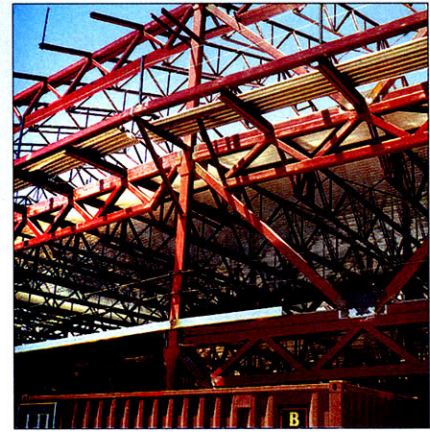
An inverted chevron braced frame is blended into a typical girder truss.
